SCOTTISH
FIRE AND RESCUE SERVICE

Fire Investigation Report

The Glasgow School of Art

15 June 2018

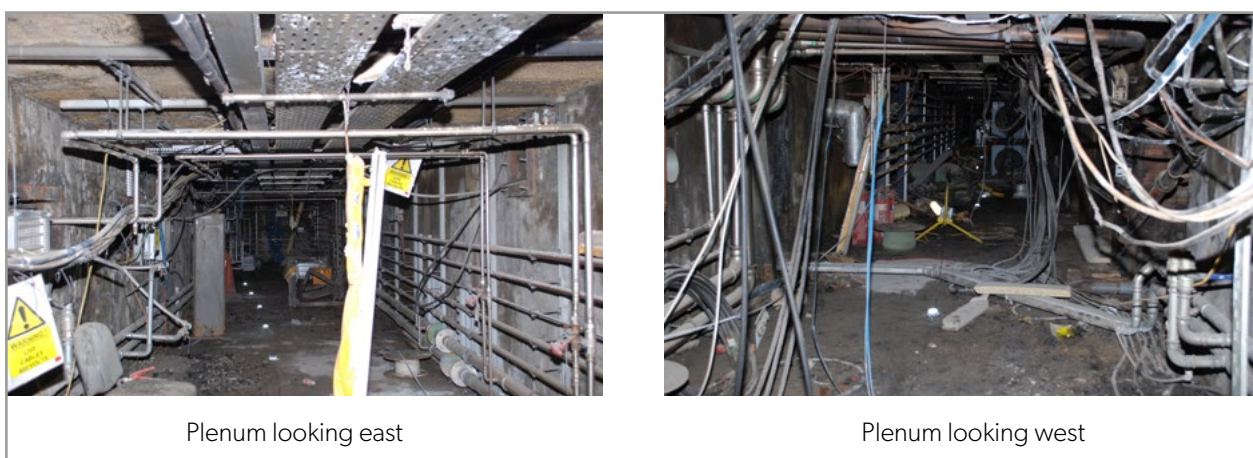
Figure 18 – Plenum below level 2

It was observed that the plenum had been utilised to route most of the electro-mechanical services for the building, including air conditioning ducts and fans, and a vast array of electrical and data wiring. Most of the wiring was observed to be secured to metal trays fastened at ceiling level. The majority of the plenum appeared to be undamaged by fire, with fire damage noted adjacent to vertical ducts which ran from numerous locations along the length of the plenum (Figure 18).

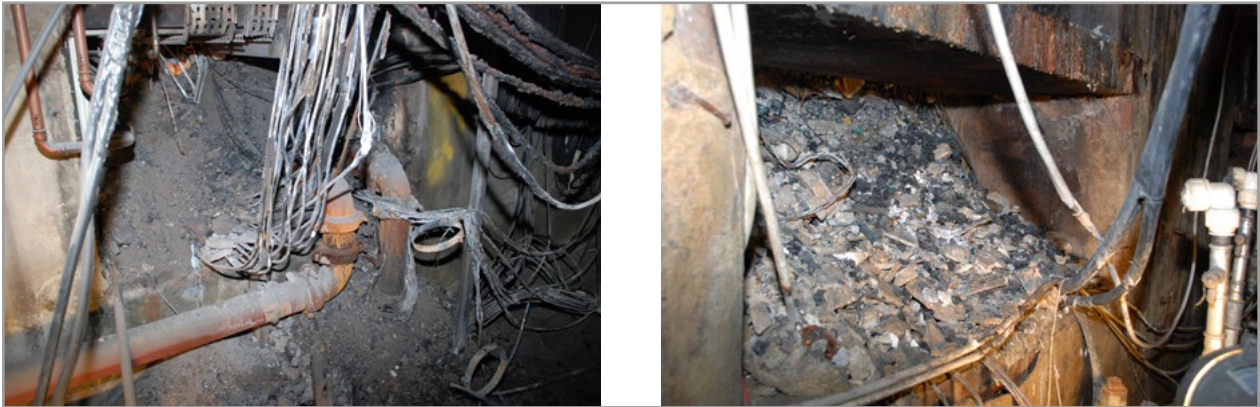
Figure 19 – Cables exiting vertical ducts into level 2 Plenum

The remainder of the vertical ducts located on the north wall and to the left of the plenum entry point (leading East), were excavated from the 4th to the 7th December 2019. The ducts were observed to contain general fire debris including bricks, mortar, wood ash and general fine dust. No large pieces of wood were observed or located within the ducts. Electrical cabling entering the ducts had sustained severe fire damage, with the remaining cable forming a tangled section within the fire debris located at the bottom of the duct (Figure 19).

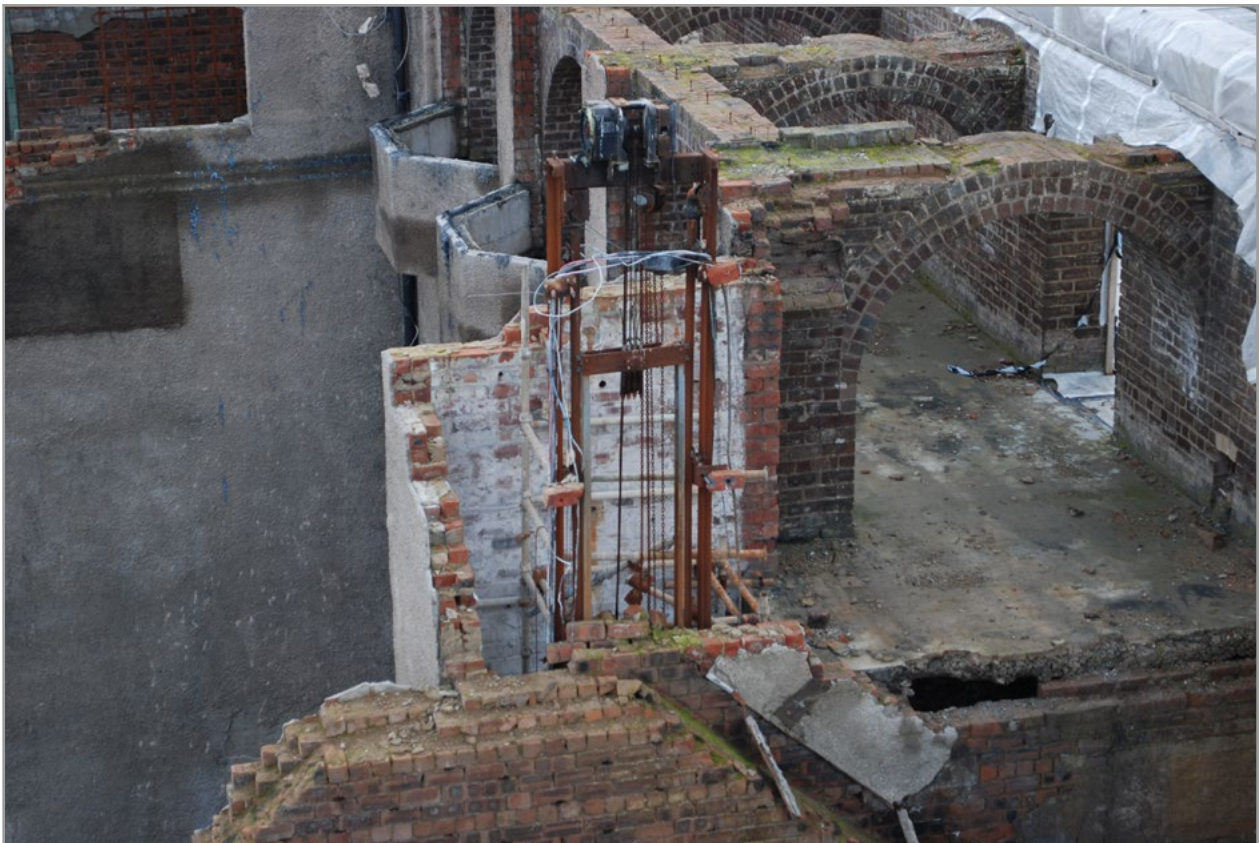
Figure 21 – Top of lift mechanism, west side

Due to the location of the lift shaft (midway along the west side of the building), both the wiring within the lift shaft and the supply cable termination at level 9 for the lift supply are not considered further as areas of origin or cause.
