SCOTTISH
FIRE AND RESCUE SERVICE

Fire Investigation Report

The Glasgow School of Art

15 June 2018

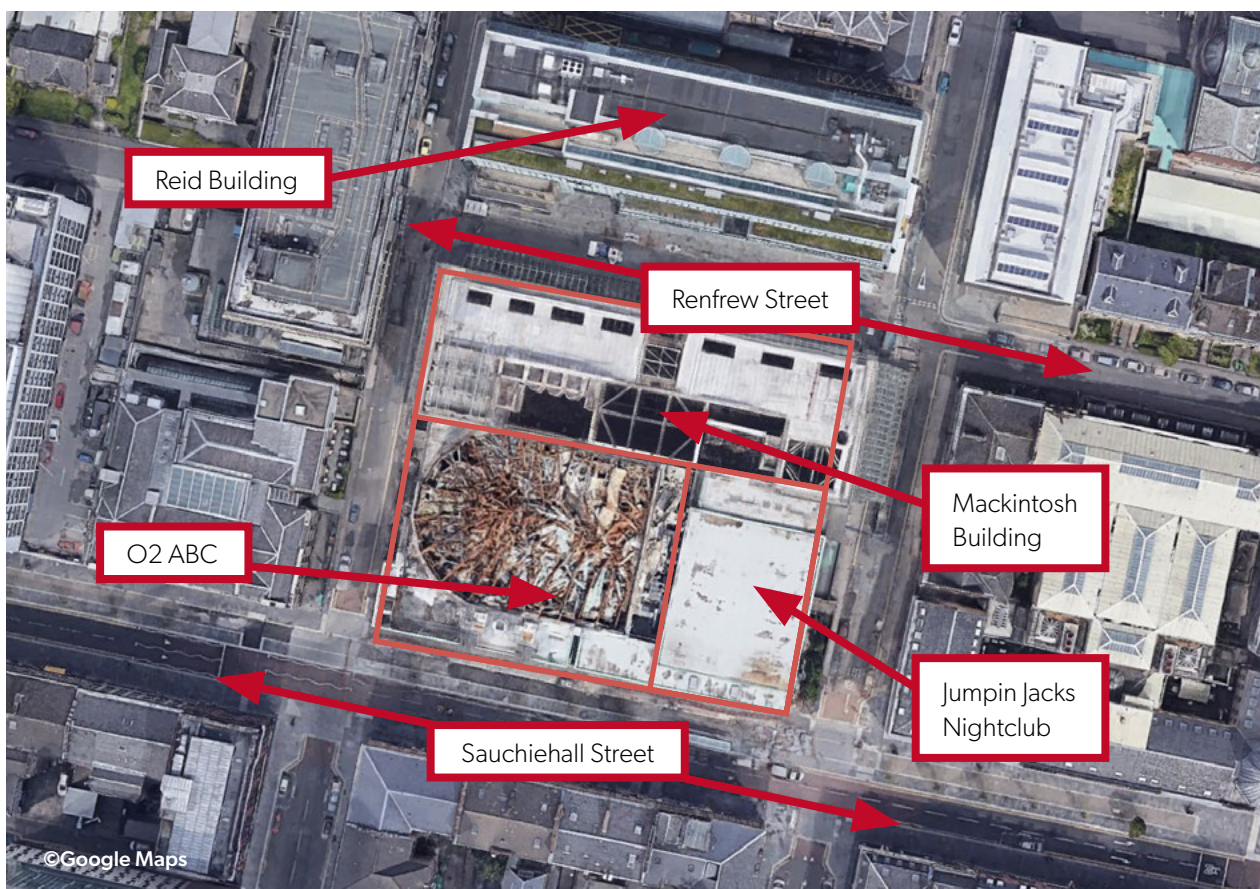
Figure 2 – Overview

Two further adjoining properties were involved in the incident as shown below in Figure 2 "Overview":

- Both adjoining properties were located to the rear (south) of the Mackintosh Building with the main access points located on Sauchiehall Street.
- Both properties suffered smoke, heat and fire damage.
- Jumpin Jaks Nightclub, 294 Sauchiehall Street (southeast) suffered smoke and heat damage with minimal internal fire damage. Further damage was arrested by the actions of SFRS firefighting crews.
- The O2 ABC, 300 Sauchiehall Street (southwest) suffered major fire damage and structural collapse despite extensive internal and external firefighting by SFRS crews. In addition, several smaller properties on Sauchiehall Street, within the same block, were also directly affected.

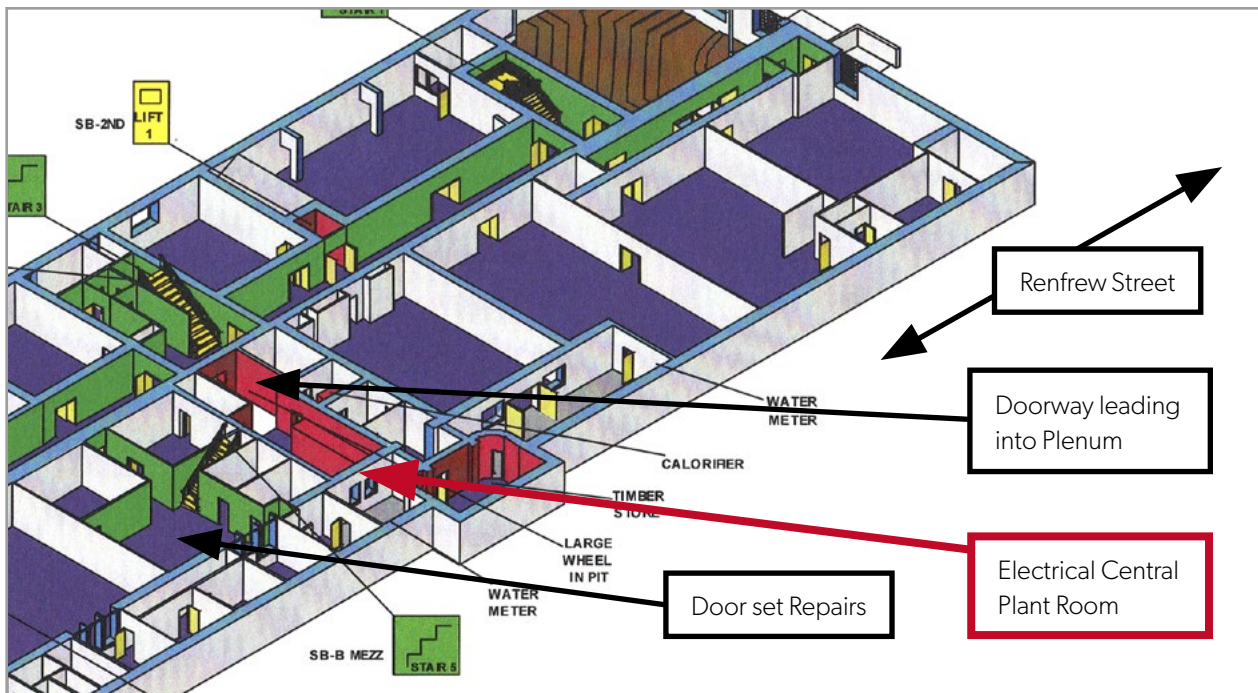
Figure 22 – Central plantroom level 2

The investigation considered seven theories that could support an electrical source as the cause of ignition.
